RISK SURVEY REPORT

DHEDHI BROTHERS (WEAVING UNIT)

Date: 16-02-2024

Location: Plot # # 27 / 1, Sector – 6 / A, North Karachi industrial area. Karachi.

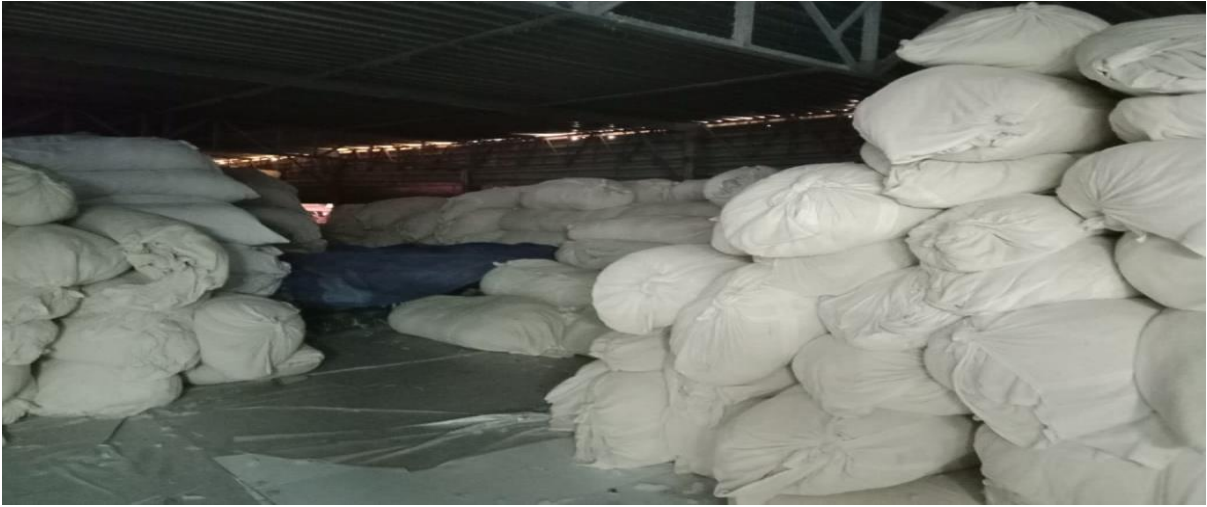
2. In grey fabric warehouse which is on mezzanine floor and has tin sheet roof, here the stacking height is nearly touching the tin roof height and sufficient distances between each stacking does not maintain. It is recommended to reduce the height of the stacking to at least 04 feet below the roof height and make sufficient distances between each stacking and place the stocks of wooden pallets. **(Critical)**

Storage of Grey fabric

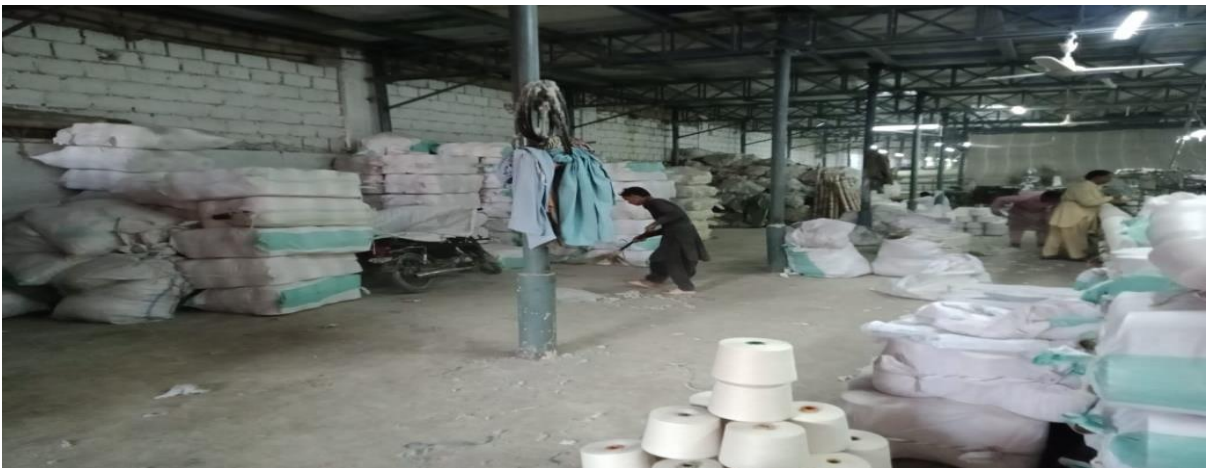
- "No Smoking Sign" not seen in factory premises including precautionary and preventive measures posters.
- The stocks of cotton yarn bags and fabric rolls placed without wooden pallets on floor in stacking position and no gaps distances maintain between each stacking and stacking height nearly touching the roof height in fabric warehouse on mezzanine floor.

Storage of Cotton yarn

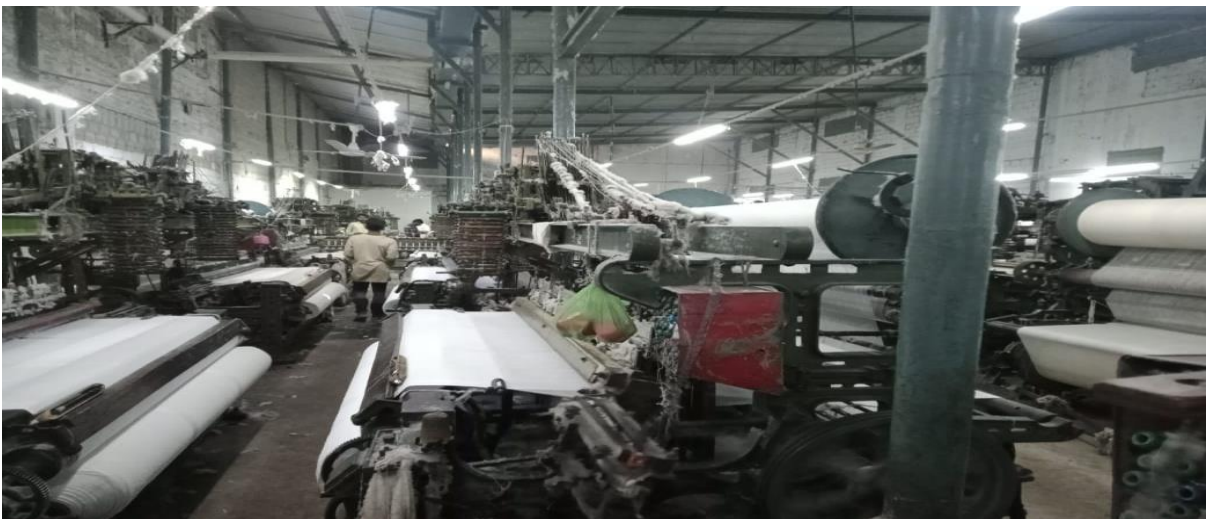
8. A huge amount of fluff is seen on floor, machines, roof and on electrical wiring and tube lights. It is strongly recommended to remove fluff and arrange air compressor for removal of fluff in each shift to avoid any fire incidence due to fluff. **(Critical)**

Fluff of equipment
