RISK INSPECTION REPORT

M/S. DAMCO PAKISTAN

**PLOT NO. A2, PORT BIN QASIM, NORTH WEST INDUSTRIAL ZONE,
KARACHI, SINDH**

M/S. SALAAM TAKAFUL LIMITED

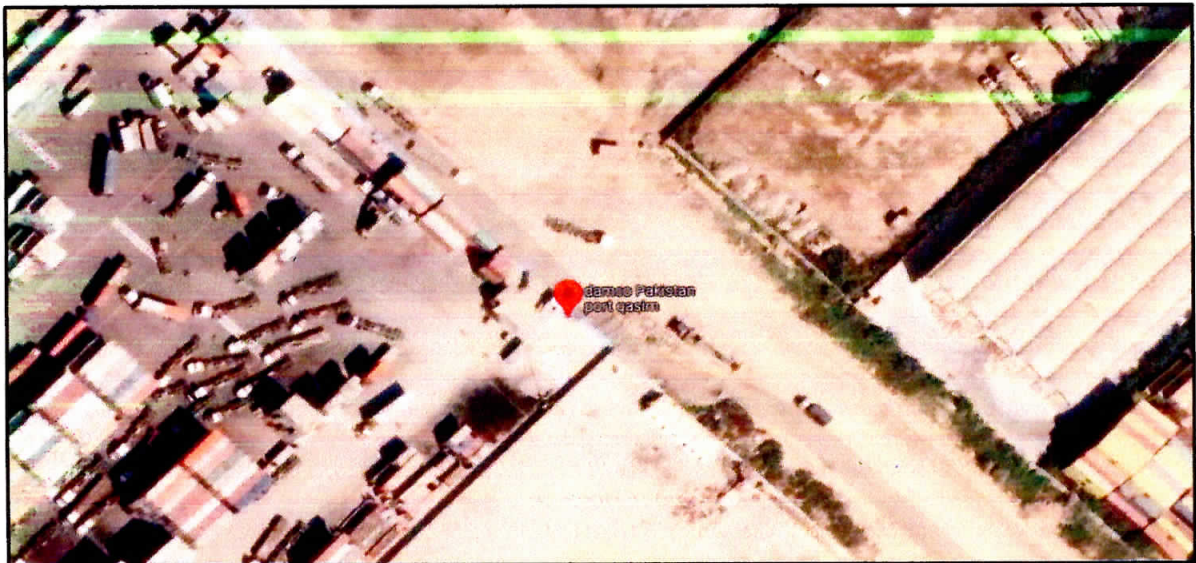
3. PLANT LAYOUT:

The Plant Layout Image taken from 'Google' also shows surrounding areas and different Units within the Property whilst the same has been discussed herewith for the perusal and record of the Underwriters.
